Fungal Resistance of Calcium Silicate Boards

22-10-2015

Order no.: 647950

Danish Technological Institute, Wood Technology

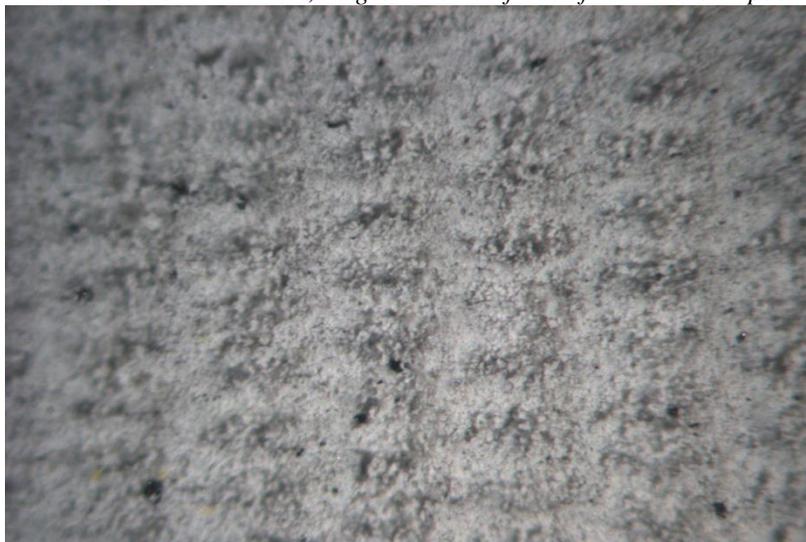
Photo 2. Skamol 15-37-10-3, no growth observed in microscope.

After 7 weeks' exposure, no fungal growth were visible to the naked eye. In the microscope, the spores were observed but no mycelium.

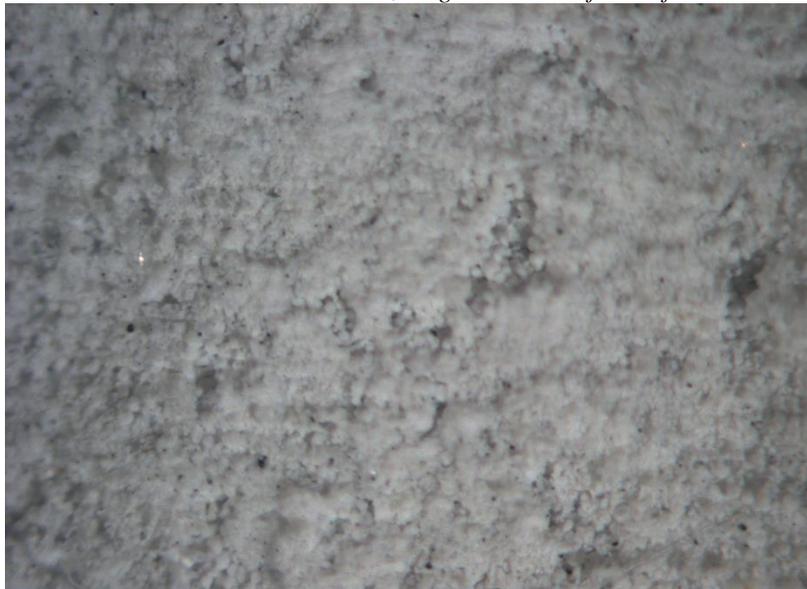
Photo 4. Skamol Yantai Haohai 130, no growth observed in microscope.

After 7 weeks' exposure, no fungal growth were visible to the naked eye. In the microscope, the spores were observed but no mycelium.

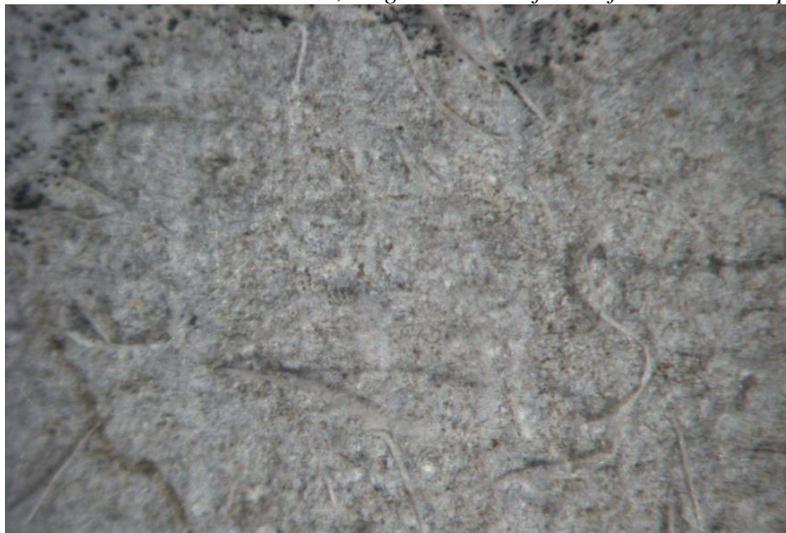
Photo 6. Skamol Skamotec 225, no growth observed in microscope.

After 7 weeks' exposure, no fungal growth were visible to the naked eye. In the microscope, the spores were observed but no mycelium.

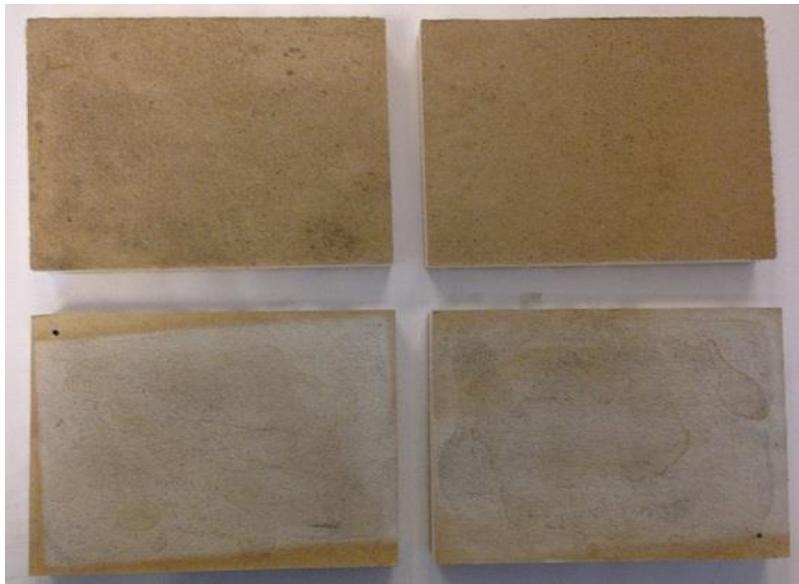
Photo 7. Gypsum boards, growth on surfaces after 7 weeks' exposure

After 5 weeks' exposure, the surfaces of the Gypsum boards reference specimens were covered with visible fungal growth, and the paper on top of the specimens was damaged by moisture. Also in the microscope, heavy growth was observed.
